TECHNICAL MEMORANDUM SUPPLEMENTAL

# **NORTH DIKE AREA**

SITE INVESTIGATION AND EVALUATION OF ORIGINAL REMEDY

BAILEY SUPERFUND SITE ORANGE COUNTY, TEXAS

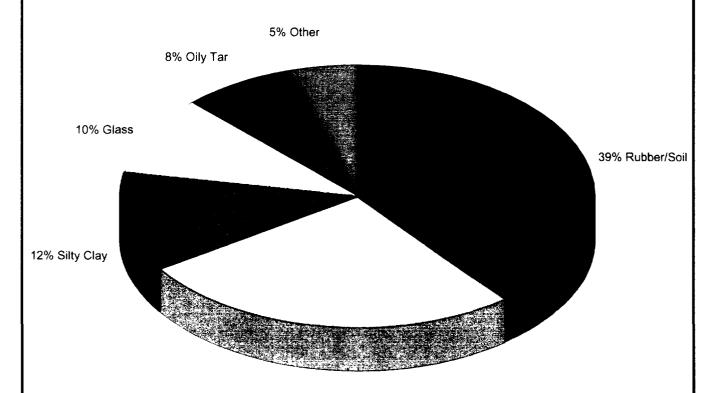
## FIGURE 7 TOTAL WASTE COMPOSITION BY WEIGHT NORTH DIKE INVESTIGATION BAILEY SUPERFUND SITE

- 39 percent rubber crumb and soil mixture;
- 26 percent decomposed MSW and soil mixture;
- 12 percent silty clay (typically located beneath the waste);
- 10 percent glass (broken bottles);
- 8 percent oily tar-like material; and
- 5 percent metal, soil, wood, pebbles/stones, and organics.

26% MSW/Soil

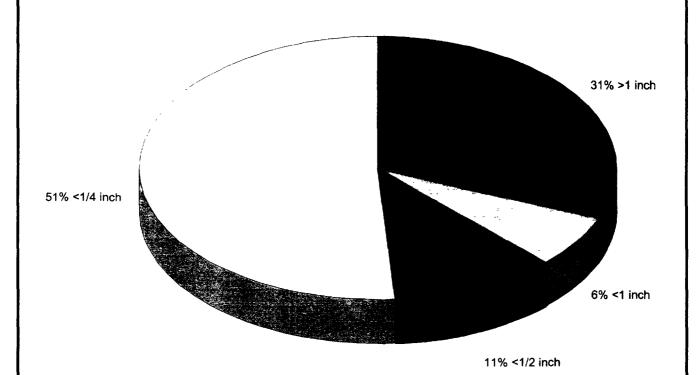
### FIGURE 8 RUBBER CRUMB/SOIL GRADATION BY WEIGHT NORTH DIKE INVESTIGATION BAILEY SUPERFUND SITE

1. Rubber/Soil was observed in 9 of the 20 test pit samples.

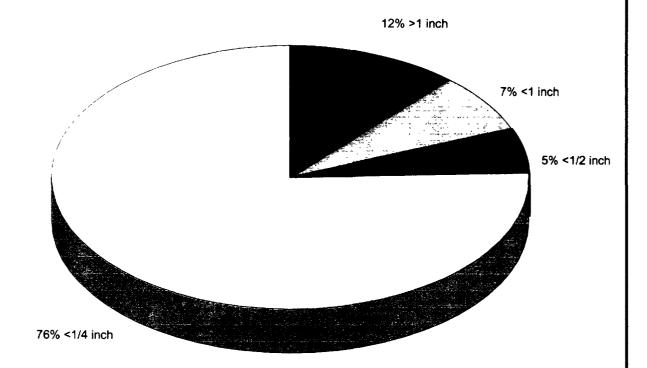
### FIGURE 9 MUNICIPAL SOLID WASTE/SOIL GRADATION BY WEIGHT NORTH DIKE INVESTIGATION BAILEY SUPERFUND SITE

1. Municipal Soilid Waste/Soil was observed in 9 of the 20 test pit samples.

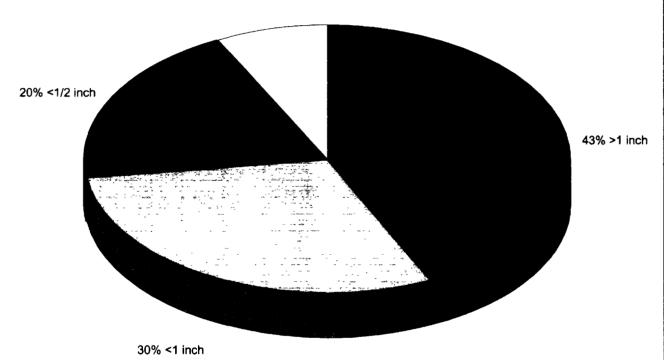
## FIGURE 10 GLASS GRADATION BY WEIGHT NORTH DIKE INVESTIGATION BAILEY SUPERFUND SITE

1. Glass was observed in 11 of the 20 test pit samples.
